FACILITY STATUS CHANGE FORM

Date Submitted: August 7, 2013 Originator: Chris Strand Phone: 554-2720	Area: 300 Area Facility ID: 3906, 3906B Action Memorandum: Action Memorandum #3	Control #: D4-300-090
---	---	---------------------------------

3906 Lift Station

3906B Lift Station

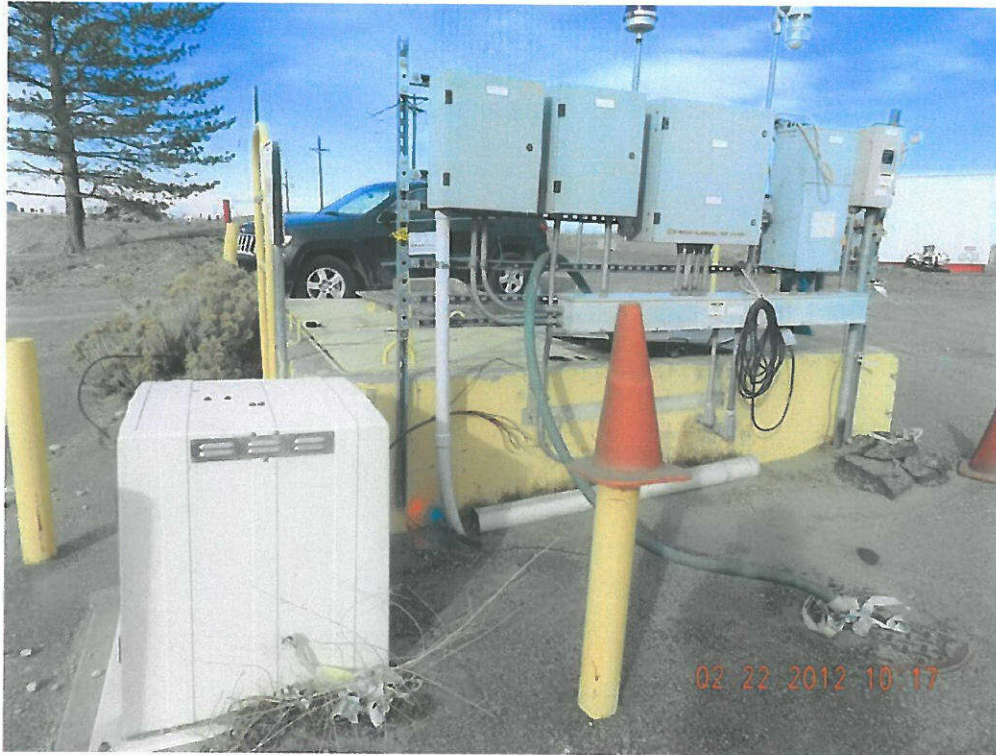
Photograph 1: 3906 Lift Station, looking west on February 22, 2013.

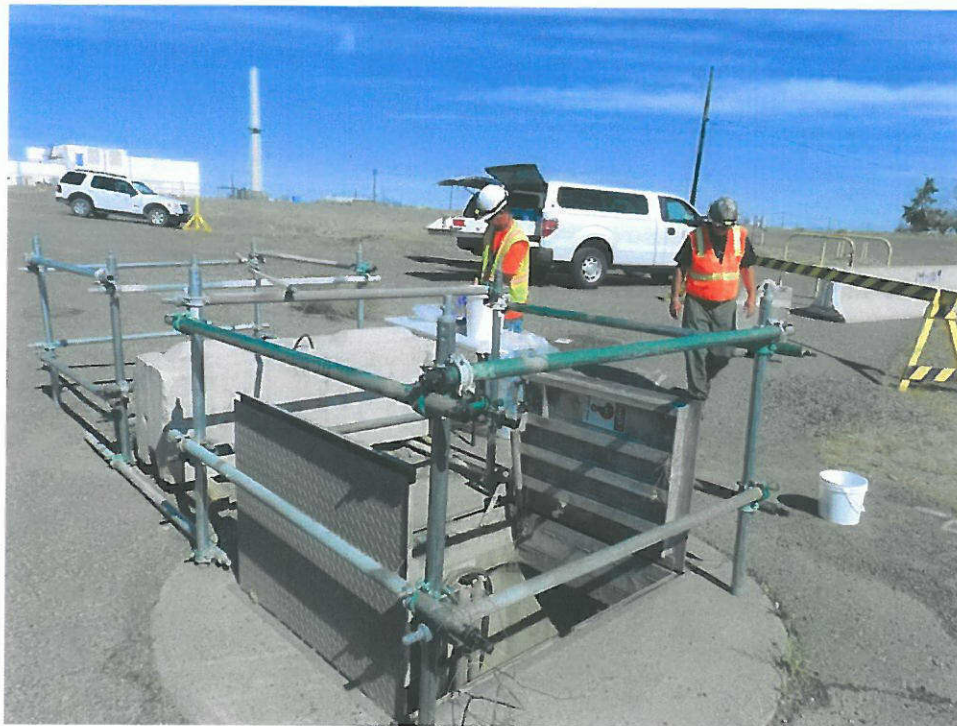
Photograph 2. 3906B Lift Station, looking northwest on July 12, 2013.

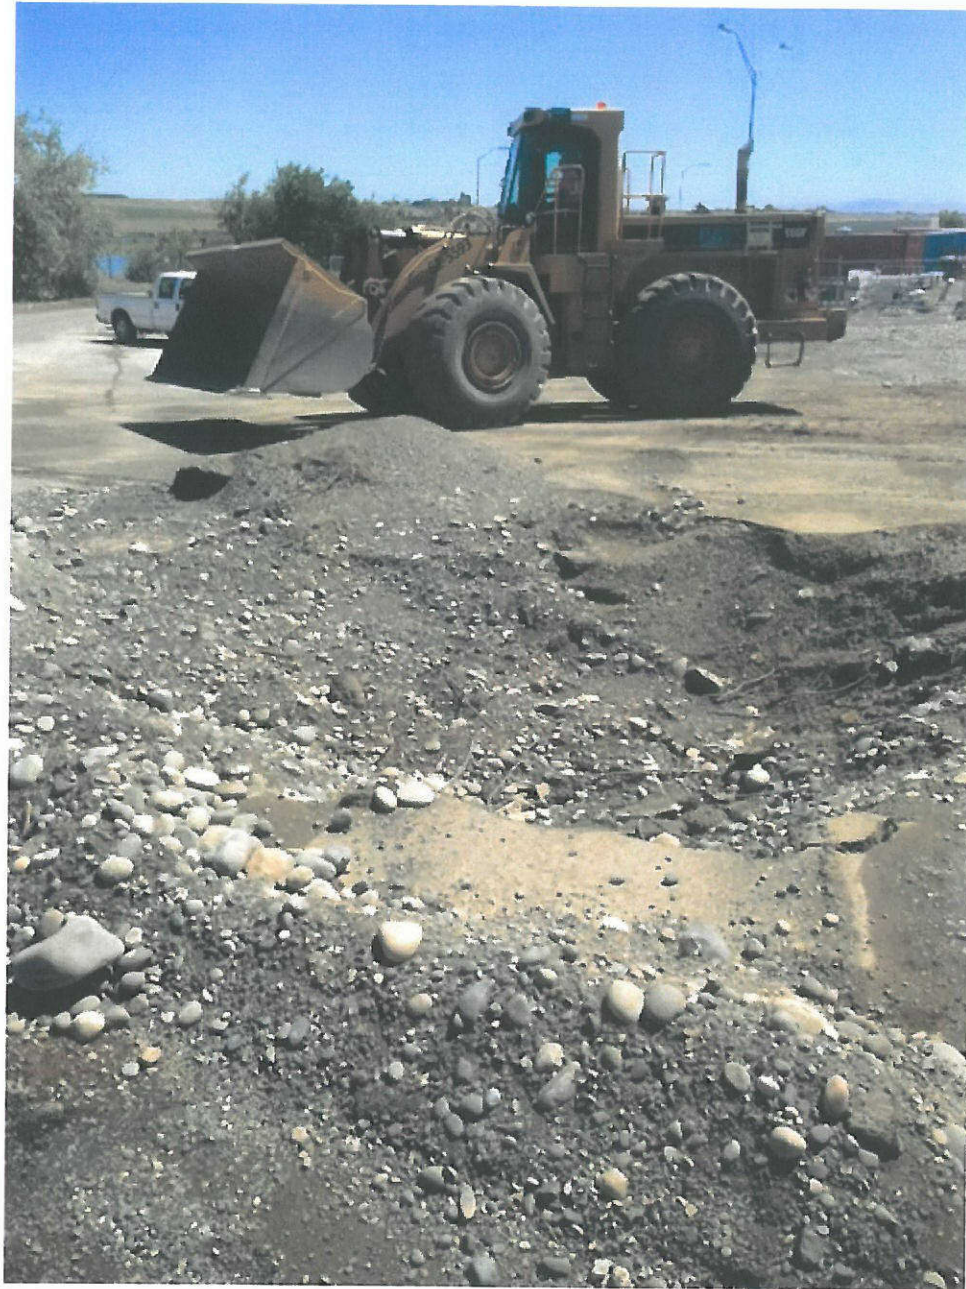
Photograph 3. 3906 excavation during backfill, looking southeast on July 15, 2013.

Both the 3906 and 3906B lift stations were backfilled with clean borrow pit material. No radiological or Industrial Hygiene posting remain. No GPERs surveys were conducted as both facilities were located outside the 300 Area industrial core Underground Radioactive Material Area. This is supported by characterization surveys that found no radiological contamination present in either structure.

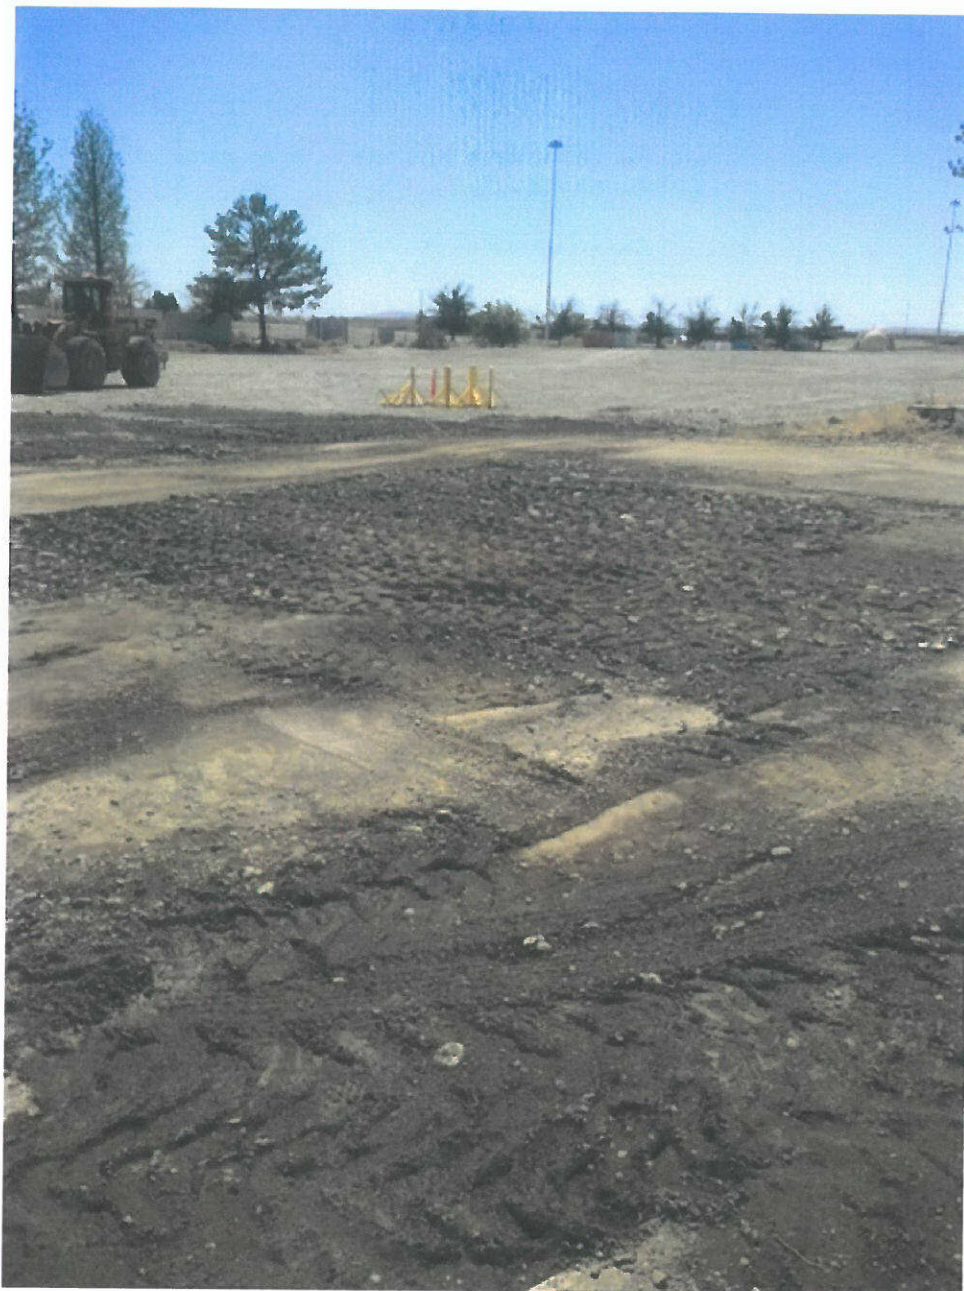
Photograph 4. 3906 excavation following backfill, looking southwest on July 15, 2013.

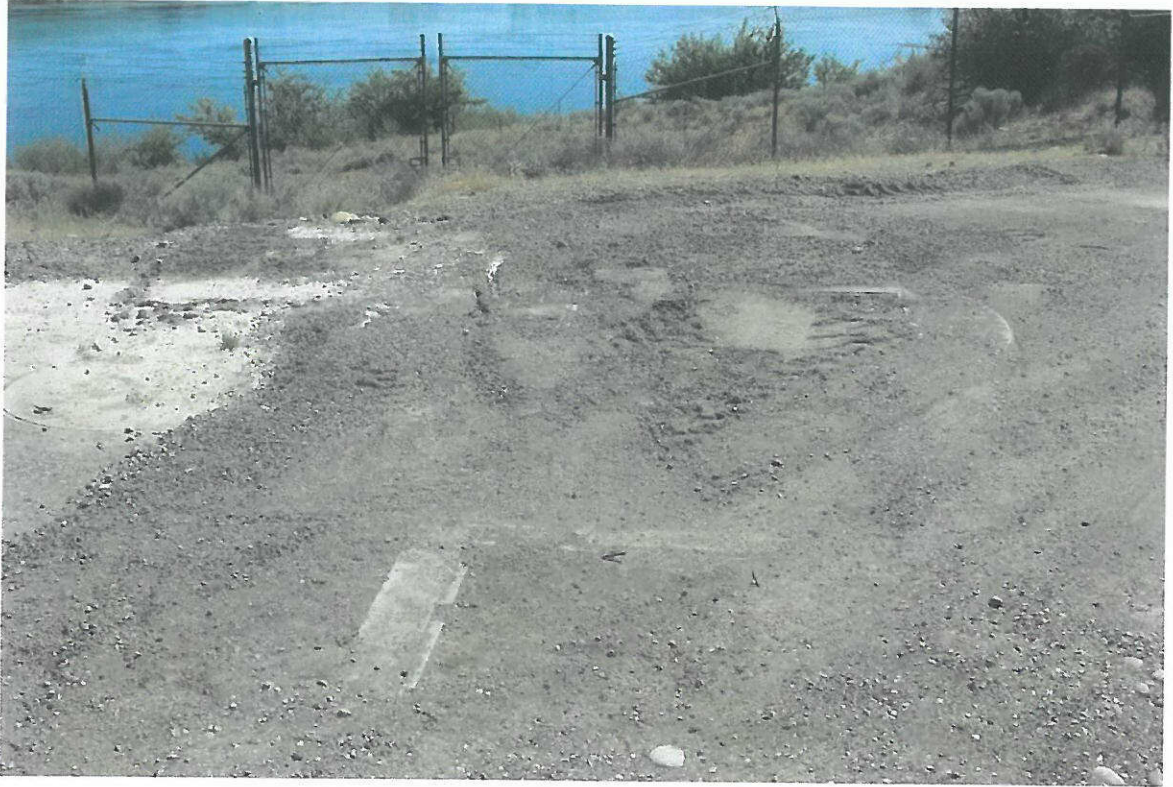
Photograph 5. 3906B following backfill, looking east on August 7, 2013.

Demolition of the one to three feet of the 3906B structure is deferred because of interferences imposed by immediately adjacent and active utilities.
